Manhole Inspection Summary

Manhole # S29G__066MH

Insp Date: **3/27/09 10:57 AM**

Location Address: **10 N Pine St**

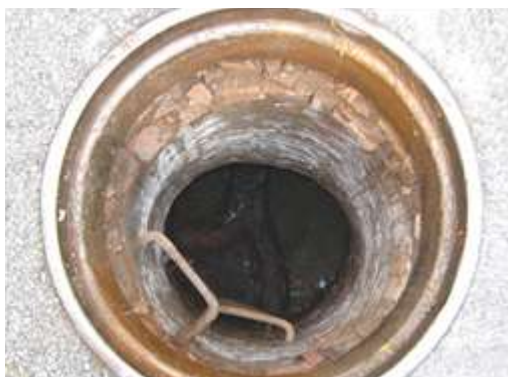
Defect 5

Condition: ☐ Sound ☐ Cracked ☒ **Leaks**

Frame cracked & leaks

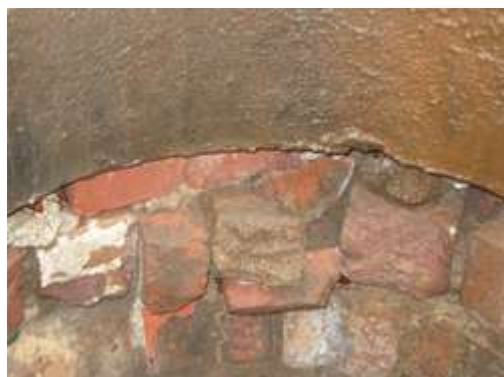
Defect 2

Offset: **2.5** (in.)

Condition: ☐ Sound ☐ Cracked ☐ Root Intrusion ☐ Loose Brick ☒ **Deteriorated**

Chimney offset 2.5"
Deterioration in chimney

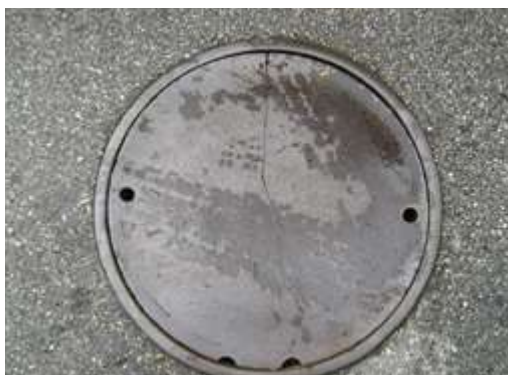
Defect 1

Condition: **Cracked**

MH cover worn and cracked

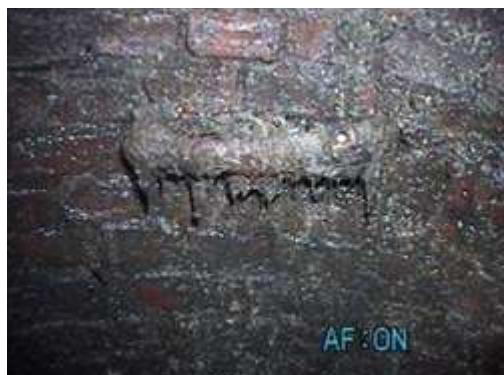
Defect 4

Count: **10** Missing: **0** ☒ **Corroded**

☒ **Evidence Of Surcharge** Depth: **8** (ft.) ☐ Active Surcharge Present

Evidence of surcharge, corroded steps

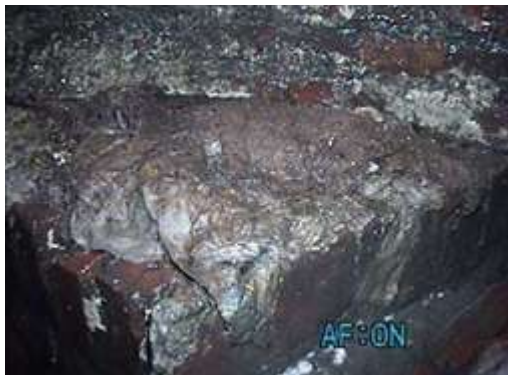
Defect 3

Condition: ☐ Sound ☐ Cracked ☐ Root Intrusion ☐ Deteriorated ☐ Leaks ☒ **Debris**

Debris on bench

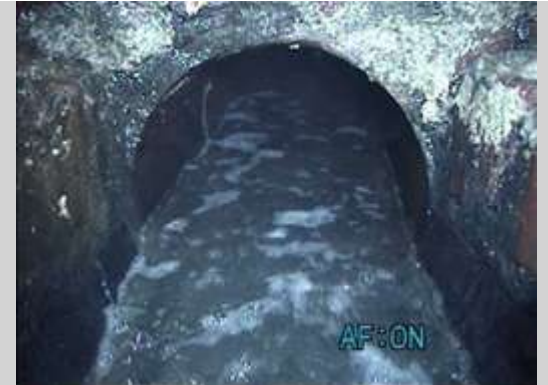
12 O'Clock Outflow

Pipe Height: **10.8** (in.) Rod and Bar (Angled)
Pipe Material: **Clay** ☐ Pipe Lined
Invert Depth: **15.40** (ft.) Flow Characteristics: **Fast**
Deposits: ☒ None ☐ Mud ☐ Sludge ☐ Debris ☐ Grease
Silt Depth: **0** (in.) Deposits Extent:
Infiltration: **None** Pipe Seal Cond: **Sound**

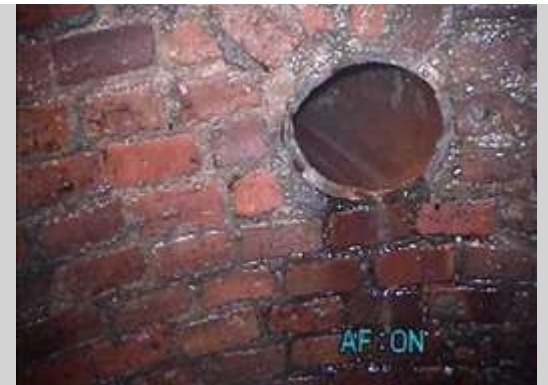
5 O'Clock Inflow

Pipe Height: **6** (in.) Rod and Bar (Angled)
Pipe Material: **Clay** ☐ Pipe Lined
Invert Depth: **11.42** (ft.) Flow Characteristics: **Slow**
Deposits: ☒ None ☐ Mud ☐ Sludge ☐ Debris ☐ Grease
Silt Depth: **0** (in.) Deposits Extent:
Infiltration: **None** Pipe Seal Cond: **Sound**

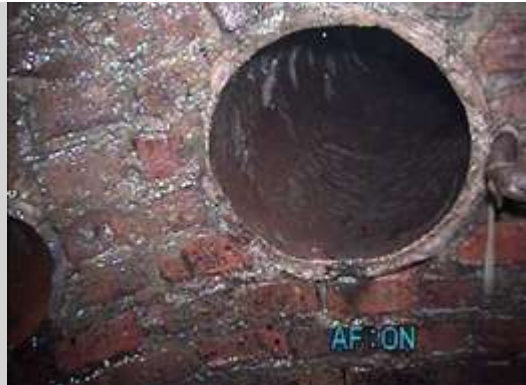
Pipe In @ 6 O'Clock

Pipe Height: **10.8** (in.) Rod and Bar (Angled)

Pipe Material: **Clay** ☐ Pipe Lined

Invert Depth: **11.40** (ft.) Flow Characteristics: **Fast**

Infiltration: **None** Pipe Seal Cond: **Sound**

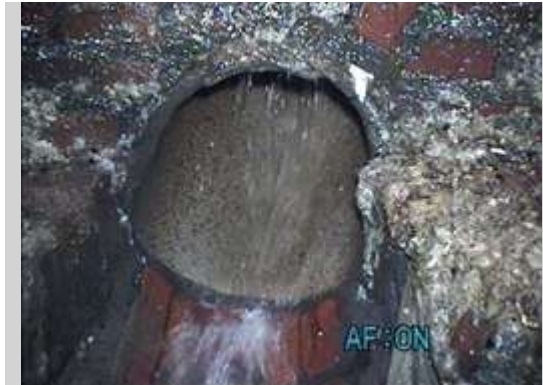
Drop In @ 6 O'Clock

Drop: **Outside** Rod and Bar
Angled: **Yes** Reading: **13.86** (ft.)
Inv Depth: **14.86** (ft.)
Drop Condition: **Open**

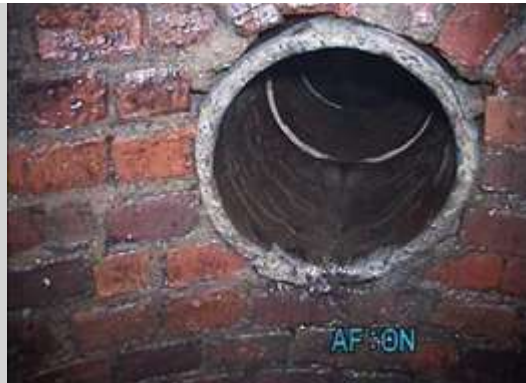
Pipe In @ 9 O'Clock

Pipe Height: **10.8** (in.) Rod and Bar (Angled)

Pipe Material: **Clay** ☐ Pipe Lined

Invert Depth: **10.96** (ft.) Flow Characteristics: **Fast**

Infiltration: **None** Pipe Seal Cond: **Sound**

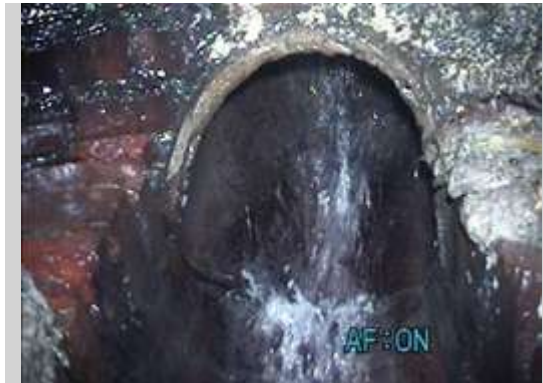
Drop In @ 9 O'Clock

Drop: **Outside** Rod and Bar
Angled: **Yes** Reading: **14.02** (ft.)
Inv Depth: **15.02** (ft.)
Drop Condition: **Open**
